TOPS Veterinary Rehabilitation

HydroFLOW Case Study: Hydro-Treadmill Therapy Pool

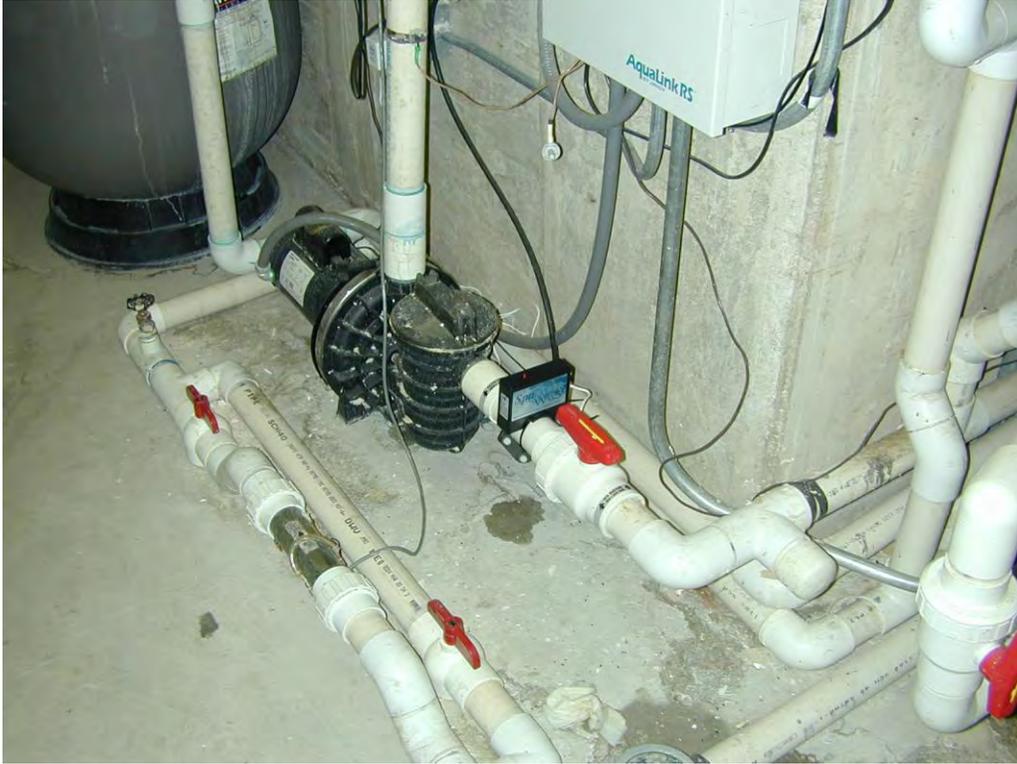
Photograph of installed *HydroFLOW* water conditioner

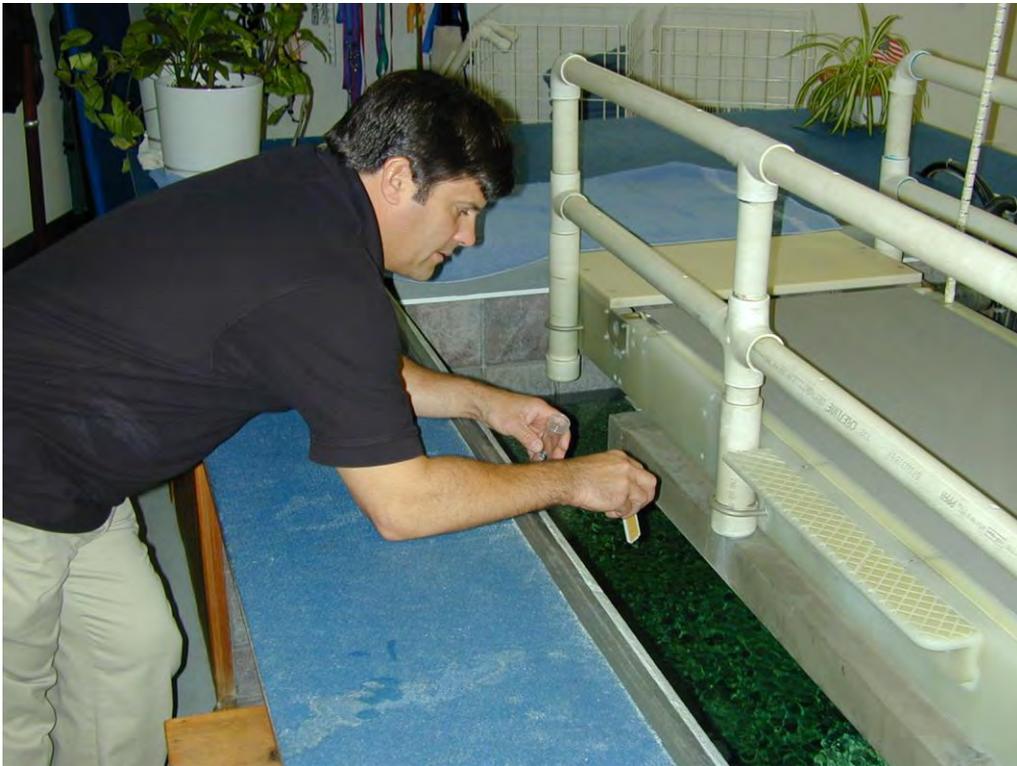
Photograph of Tom McCauley taking bio measurements using a dip slide

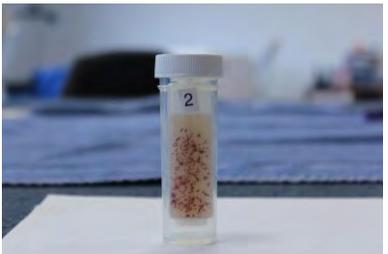
<p>Following normal protocol, (without <i>HydroFLOW</i> installed and normal chemical additions) our pool wall shows many colonies.</p>
<p>Prior to <i>HydroFLOW</i> installation. This reading therefore is after the pool water has stabilized (pH, etc.) following the backwash. Expected result is minimal colonies.</p>

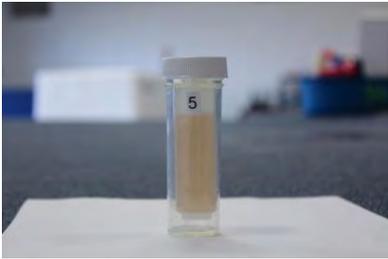
<p>After two weeks with <i>HydroFLOW</i> and normal chemical dosage, but without additional backwash having taken place. This tests if the <i>HydroFLOW</i> system has any negative effect on bacteria levels and also gives us a baseline with the <i>HydroFLOW</i> system but without a chemical reduction.</p>

<p>Test shows that the <i>HydroFLOW</i> had not increased bacteria levels. No colonies appeared. ** Note, test 5 eventually developed 10 colonies. I happened to look at the slides on 3/15 (5 days post dip), and noted that all the other dips tests hadn't changed, but this one went from 0 to 4.</p>
<p>After four weeks with <i>HydroFLOW</i> and normal chemical dosage, but without additional backwash having taken place.</p>

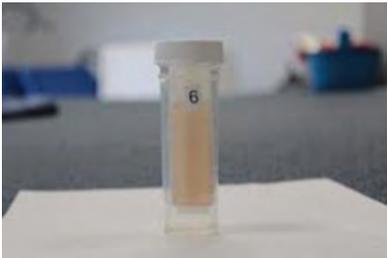
<p>Test shows that the <i>HydroFLOW</i> had not increased bacteria levels. No colonies appeared, even as the date elapsed since the prior backwash continued to grow.</p>

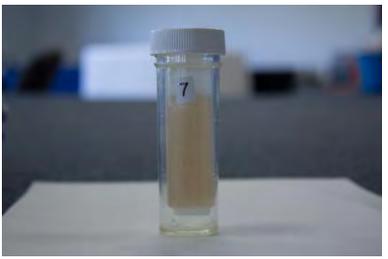
<p>After six weeks with <i>HydroFLOW</i> and normal chemical dosage. Backwash and chemical reduction taking place next.</p>

<p>Test shows that the <i>HydroFLOW</i> had not increased bacteria levels. No colonies appeared, and the elapsed time between previous backwash has reached its maximum. No effect on filter pump pressure was seen.</p>
<p>After eight weeks with <i>HydroFLOW</i> and chemical reduction of 25% and with Copper system turned off.</p>

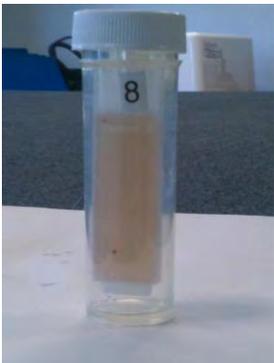
<p>We are now testing the <i>HydroFLOW</i> with our copper ionization sanitation system removed from service and chemicals reduced by 25%. This followed a backwash. Test confirms <i>HydroFLOW</i> can effectively maintain a bacteria free environment even with a 25% chemical reduction.</p>

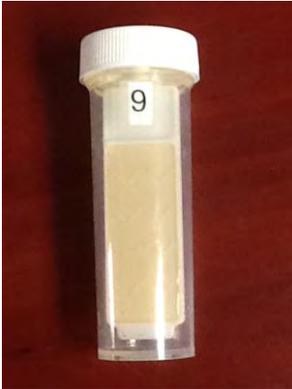
<p>After 1.5 weeks with chemical reduction of 50% and Copper system turned off (9.5 weeks into the test).</p>

<p>Although our intention was to reduce chemicals by 25% this test shows further reductions to 50% of our (normally low anyway) still maintain a bacteria free presence with the <i>HydroFLOW</i> system in place.</p>
<p>Conclusion of test pool wall test. We did not expect dramatically different results than start of test, due to the bacteria harboring nature of the pool plaster.</p>

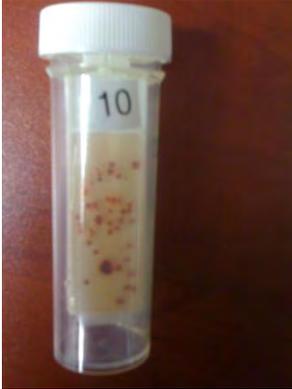
<p>There is a definite improvement in the amount of bacteria on the pool walls as a result of the <i>HydroFLOW</i> system being in place. We expect further reductions to take place as time passes.</p>

1. There continued to be no effect on the greenish color of the pool walls. This was not a promised result, but a possible one.
2. We believe the data to conclusively show that we could reduce chemical usage in our pools and maintain a sanitary environment by implementing the *HydroFLOW* system.
