## Case Study - Fast Food Restaurant - Scale (One-month Test Evaluation)

**Application:** Scaling problems with water heater and ice machine.

**Device:** *HydroFLOW* HS48 and S38 water conditioners.

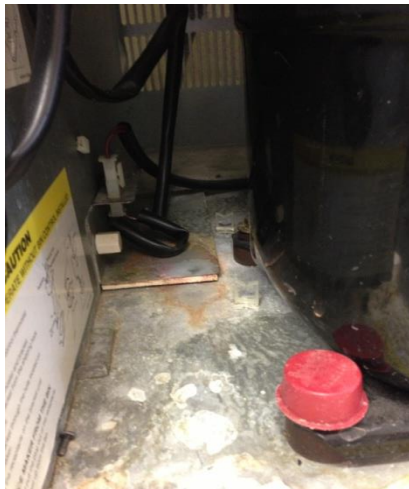
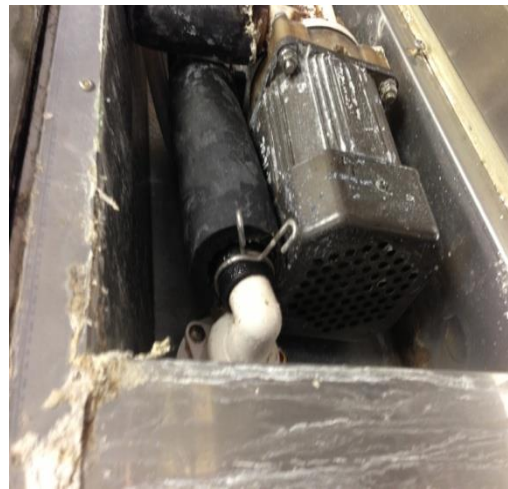
These are two pictures of the ice machine on the day the *HydroFLOW* devices were installed. The location had just cleaned them the day before. The city water flows through a water softener and a filter system before entering the ice machines. The maintenance manager would expect to clean the ice machine of scale at least every month.

An HS48 water conditioner was installed on the copper pipe at the location where the water enters the restaurant.

An S38 water conditioner was installed after the filter system and before the ice machine to protect it from scale.

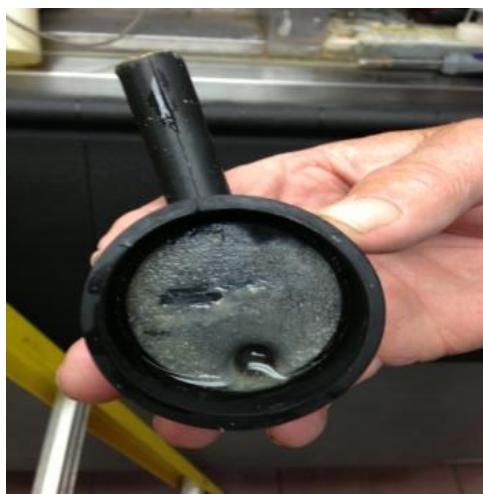
Very little scale was found upon opening the ice machine. The minuscule scale that was present was mushy and easily wiped off. The maintenance manager also noticed that the pipes were de-scaling.

This is a picture of the maintenance manager holding a reservoir located at the bottom of the ice maker. This would have been full of solid scale in the past. Today, what scale is present is very mushy and was easily wiped off.
