Canine Connection

Veterinary facility rehabs canine therapy pools with new treatment system

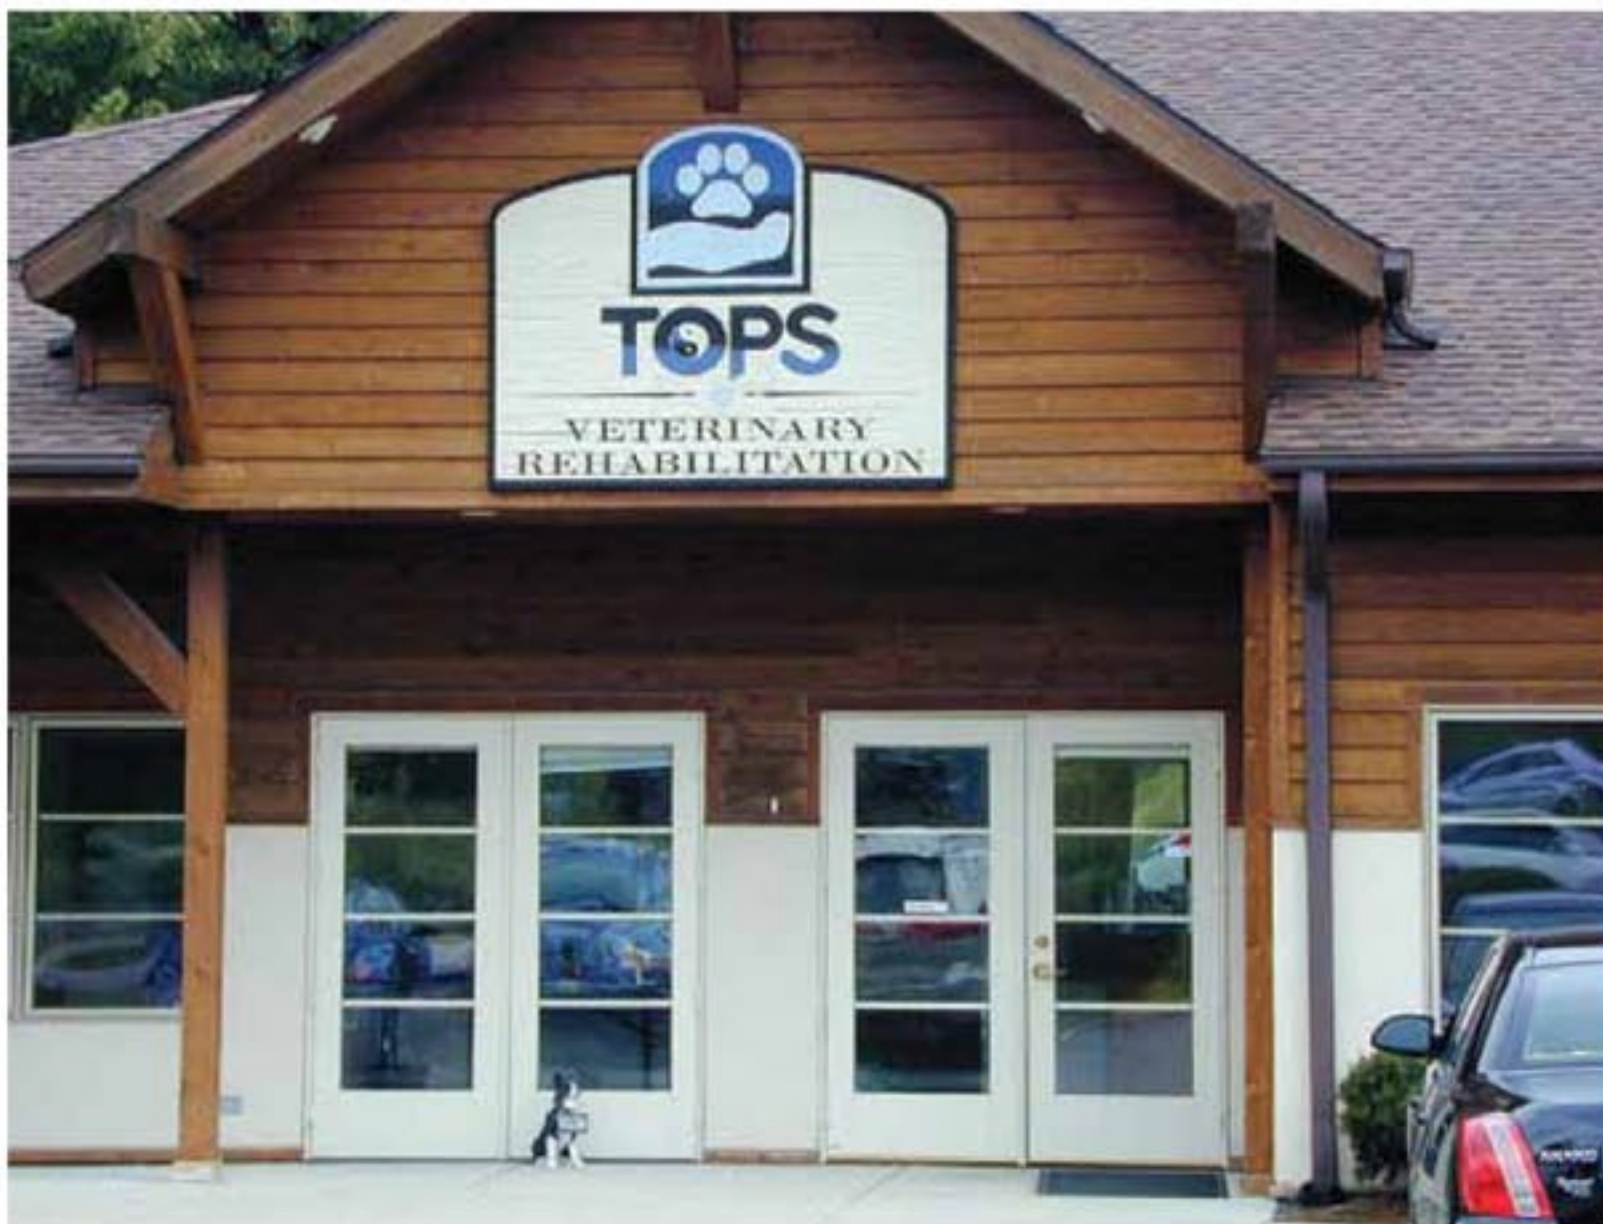
The TOPS Veterinary Rehabilitation facility employs two 1,000-gal pools for hydro-treadmill therapy.

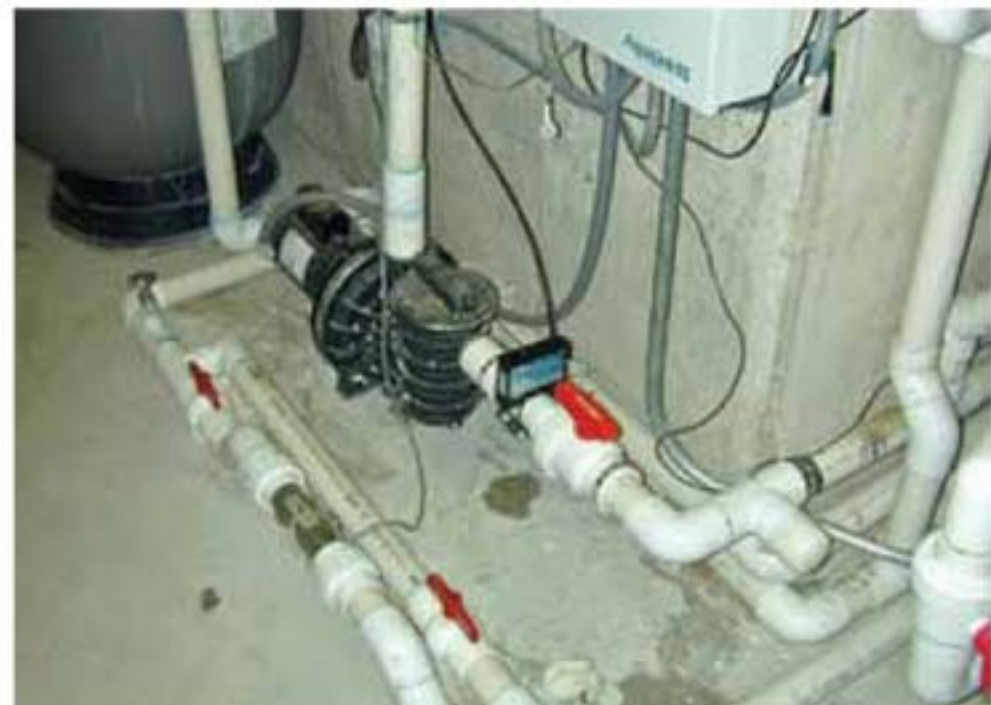
TOPS installed the new conditioning system in an effort to decrease the use of chemicals to control water quality.

The HydroFlow system was then installed, and TOPS continued with its normal chemical dosage schedule, but with no additional backwash. The purpose was to determine whether the HydroFlow system had any negative effects on bacteria levels, and to provide a baseline with the new system, but without a reduction in chemicals. After two weeks, tests showed that the new system had not increased bacteria levels, with no colonies appearing.

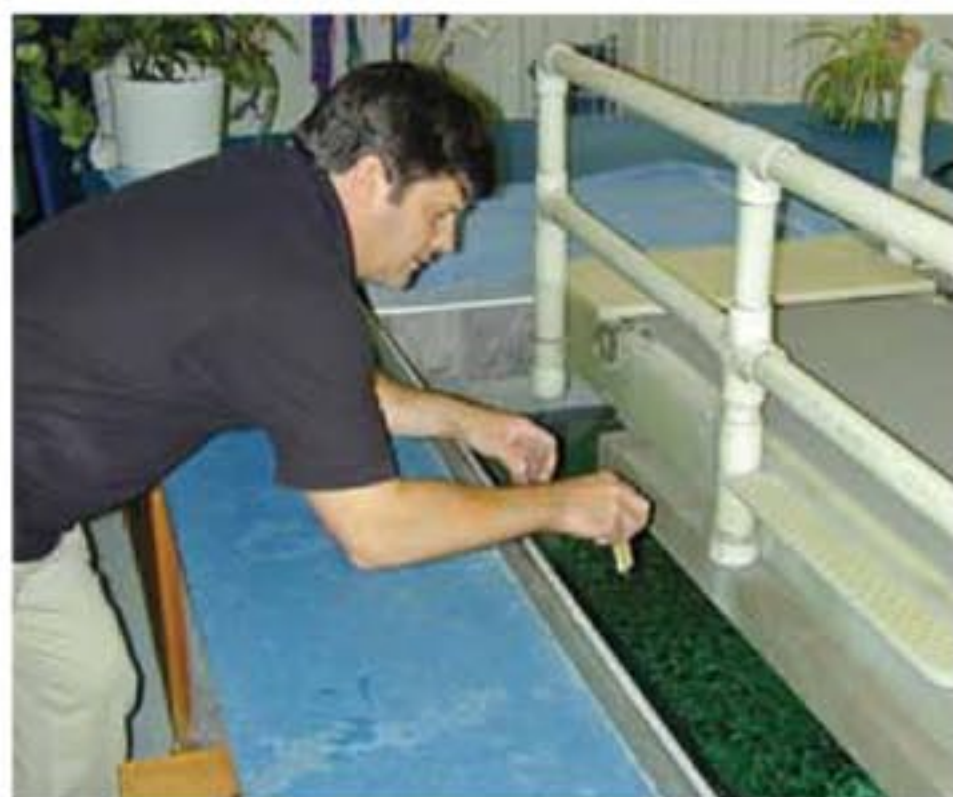
Owner Tom McCauley takes a measurement in one of the hydrotherapy pools using a dip slide.
